MKLXXxx Internal Flash Memory Instructions Manual

DTS INSIGHT CORPORATION

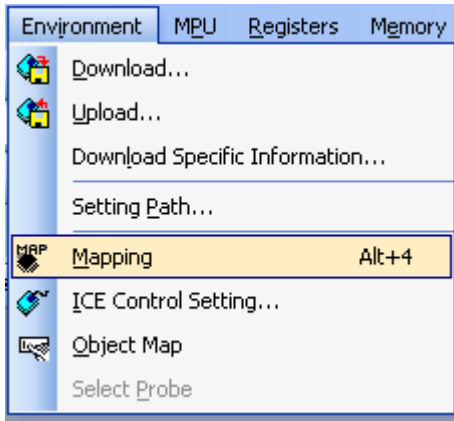
Open the memory mapping window by clicking **Environments – Mapping**.

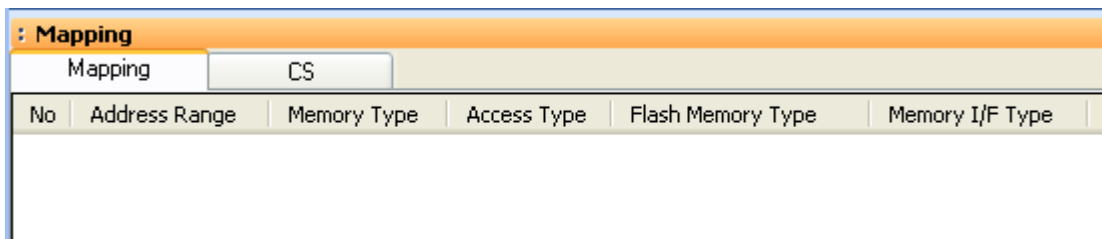
Memory map window as below is opened.

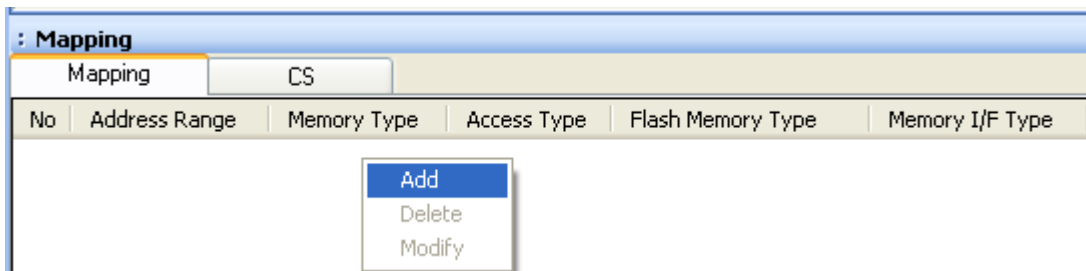
Right-click on the memory mapping window, and then select **Add**.
